Wire Rope Products

Edition September, 2019

Container Crane

J-AM Rope (J-Witex Anti-Martensite Wire Rope)

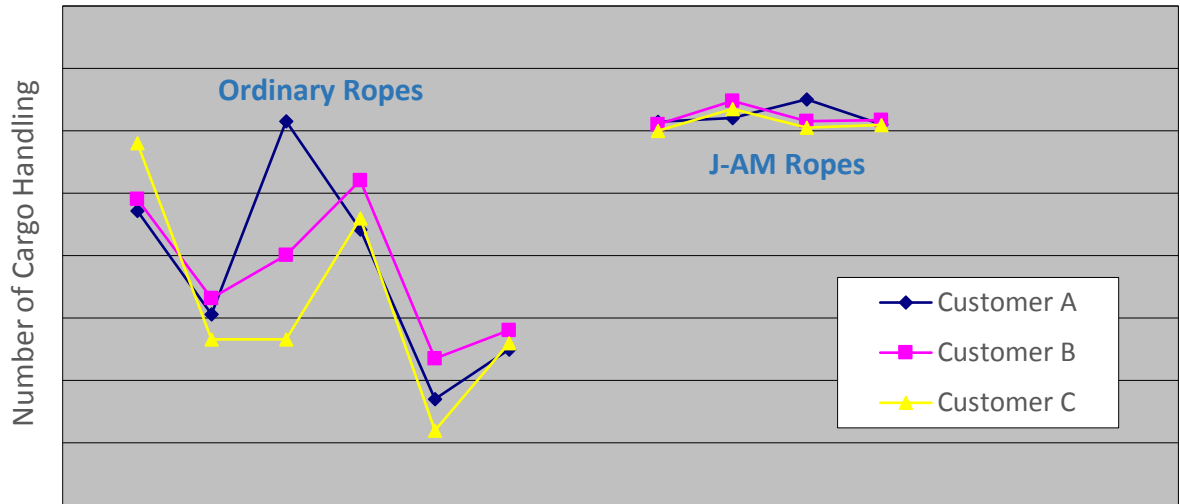
Graph 1 Comparison for Stability and Life Time

Transition of Replacement
(a specific crane at each customer with ordinary ropes and J-AM ropes)

Finding by J-Witex is that emergences of the Martensite result in a variation of the service life of each wire rope which leads the variation in its replacement cycle, and also shorter service lives.

This is a major Customer-feedback which is asking for stable maintenance intervals and longer service lives, and J-AM Rope solves these problems.

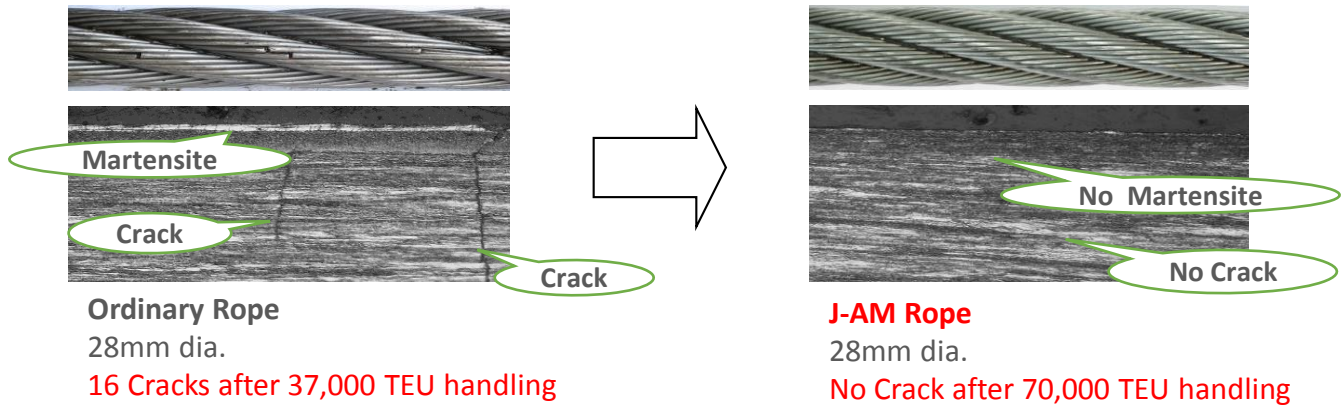
Photo 1 Let's take a closer look !!

Checking the cause of damage from the damaged samples, structural transformation to Martensite* are observed very often, which likely have been explained as a result of Metal Fatigue.

The improper structure is caused by external stress such as hitting, rubbing, etc. on the rope surface, and sudden increase of its thickness by the stress makes cracks, resulting in variation in its replacement cycle and shorter life-time of the rope.

- is a very hard and brittle steel crystalline structure.
- is formed by heating above the transformation temperature and then rapidly cooled.
- is caused by external stress such as hitting, rubbing, etc. on the rope surface, and sudden increase of its thickness by this structural transformation makes cracks.
